UNDERWATER BRIDGE INSPECTION REPORT

STRUCTURE NO. 73551

SAUK RIVER

DISTRICT 3 - STEARNS COUNTY

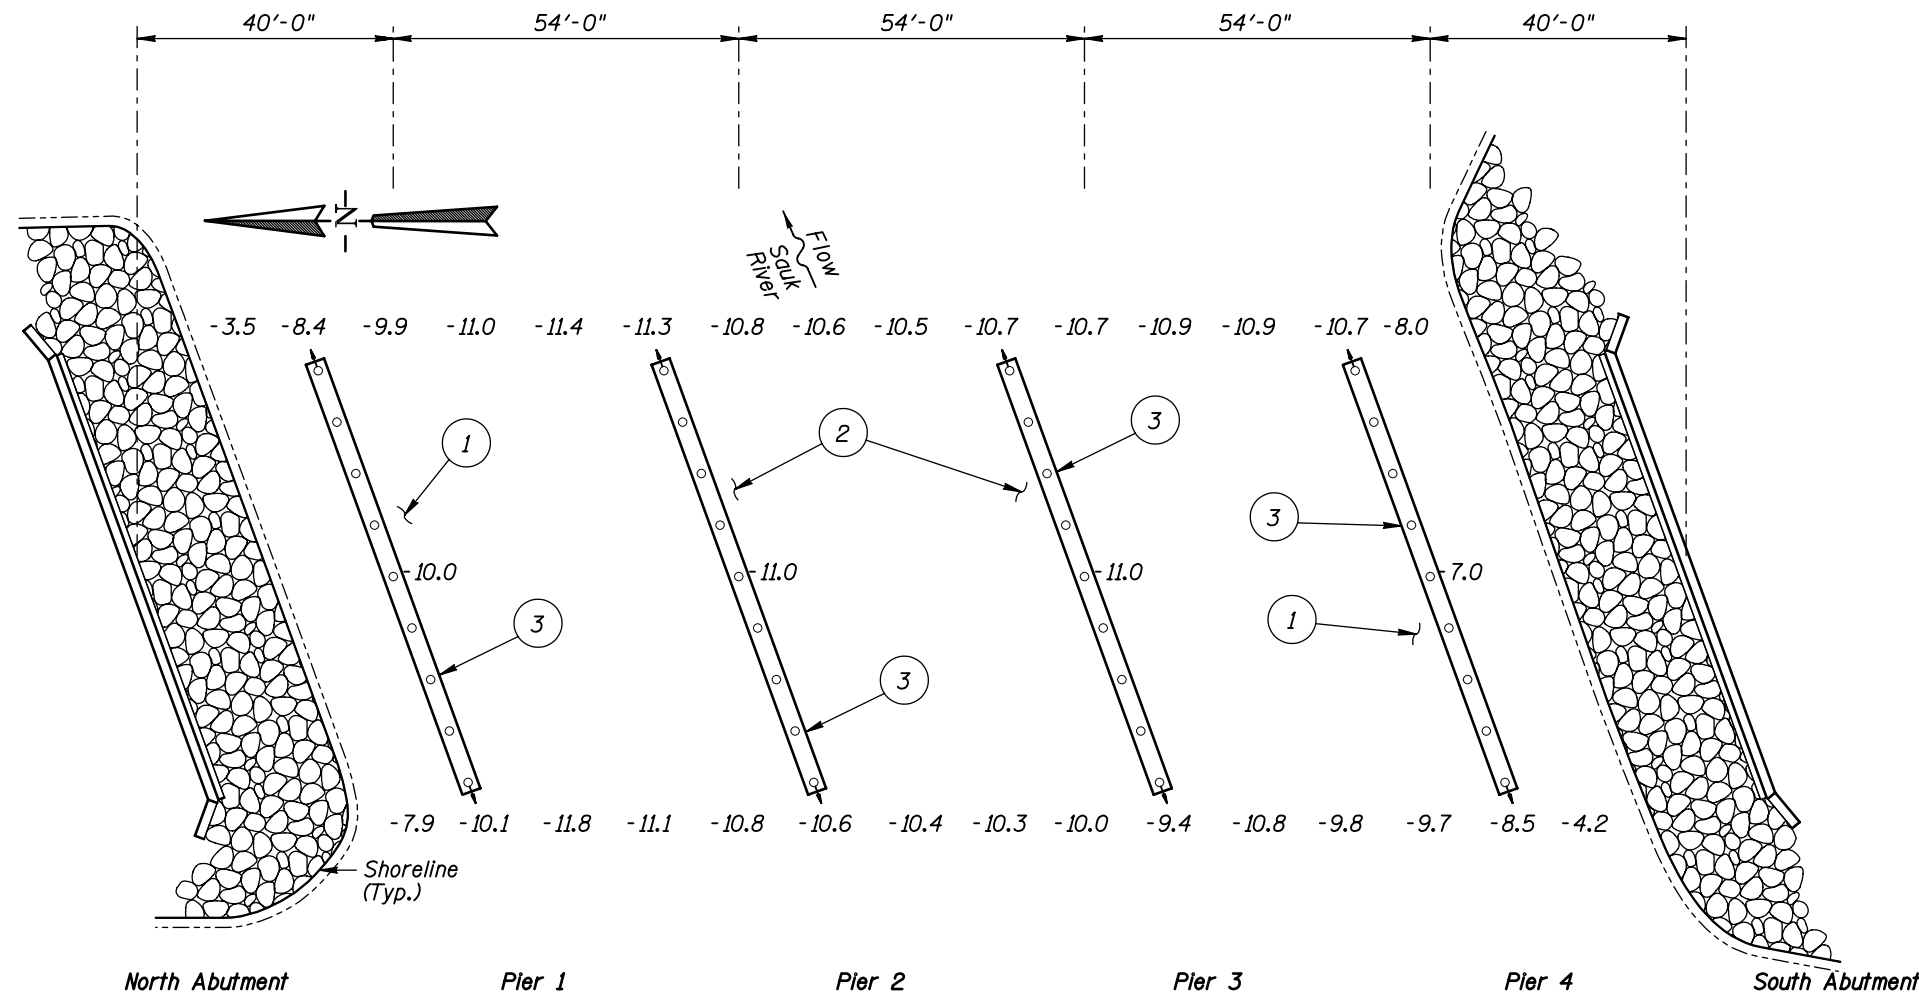
INSPECTION AND SOUNDING PLAN

- The channel bottom material around Piers 1 and 4 consisted of up to 1 foot diameter riprap.
- The channel bottom material round Piers 2 and 3 consisted sand and some stones with up to 4 inches of probe rod penetration.
- All of the piles for Piers 1 through 4 exhibited coating loss from 1 foot above the waterline to the mudline with minimal steel deterioration and with light aquatic growth on the surfaces below the waterline.

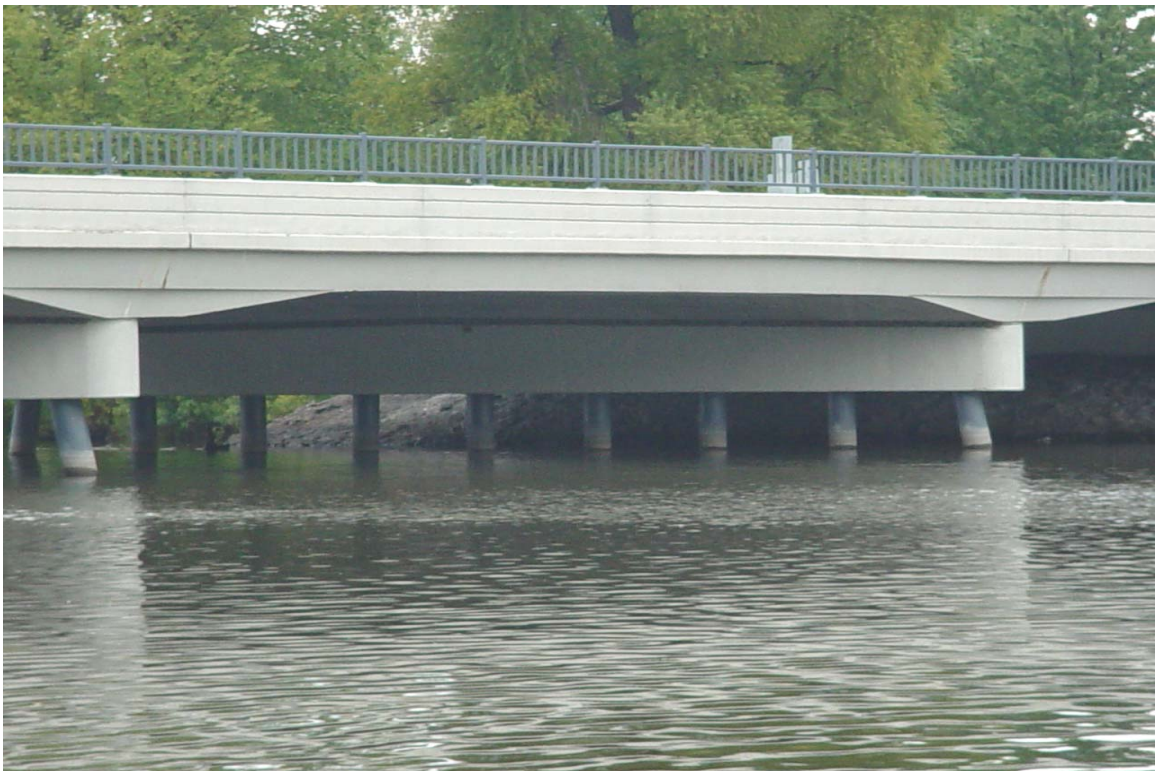
Photograph 2. View of the Pier 1, Looking Northwest.

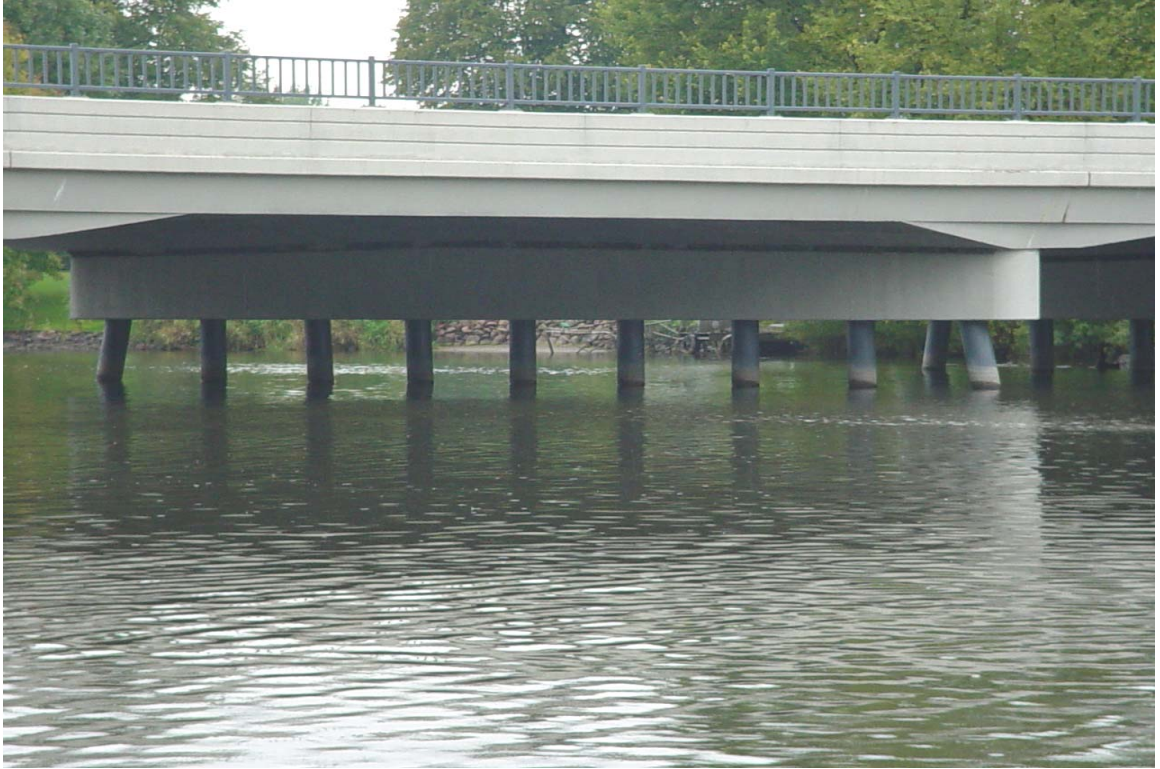
Photograph 3. View of Pier 2, Looking Northwest.

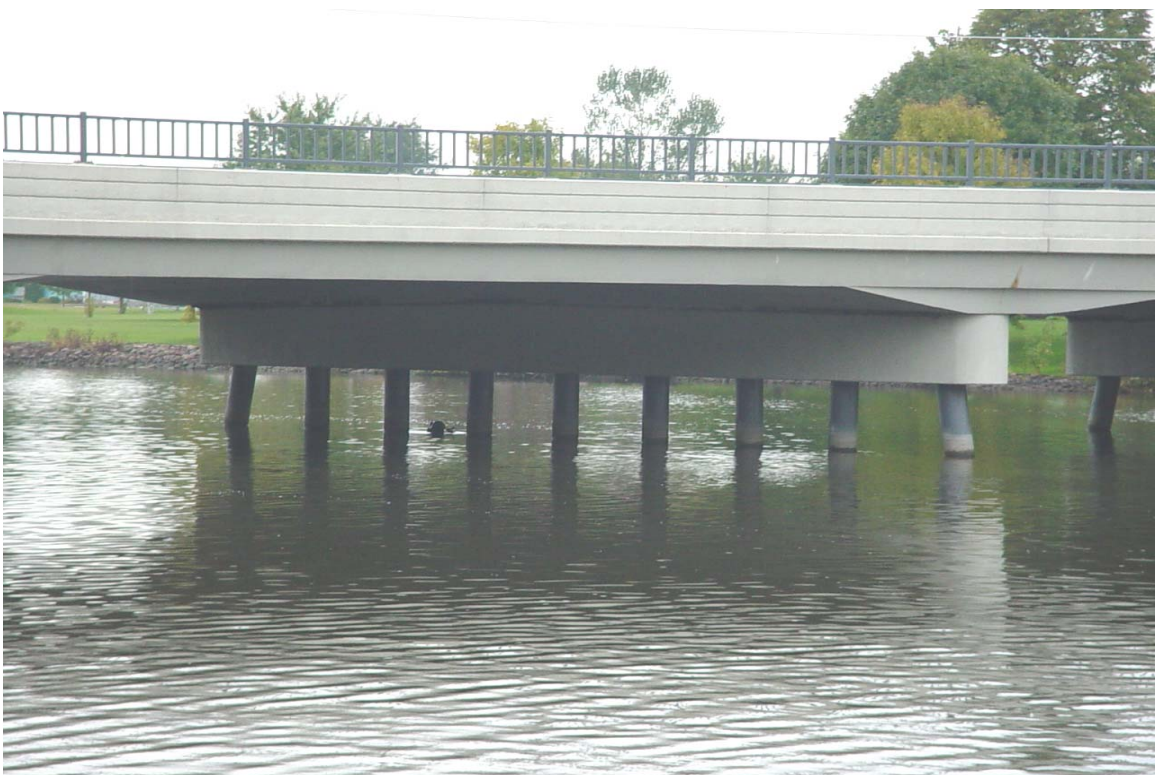
Photograph 4. View of Pier 3, Looking Northwest.

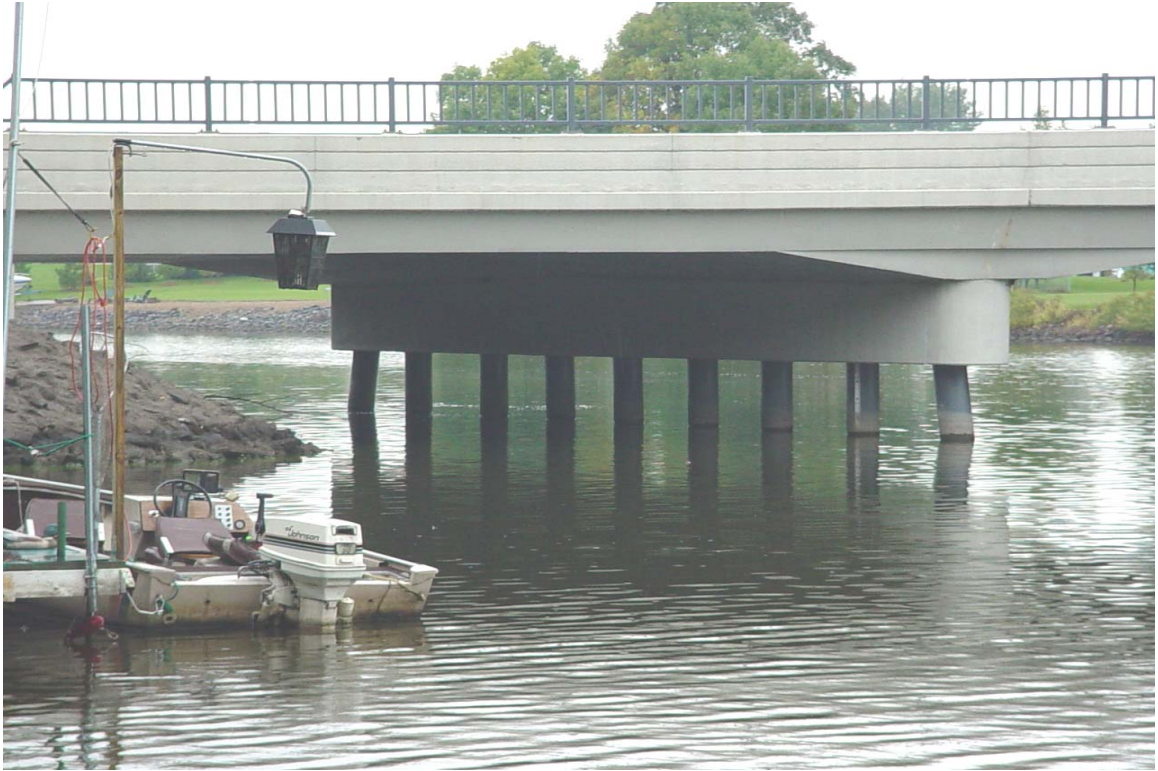
Photograph 5. View of Pier 4, Looking Northwest.

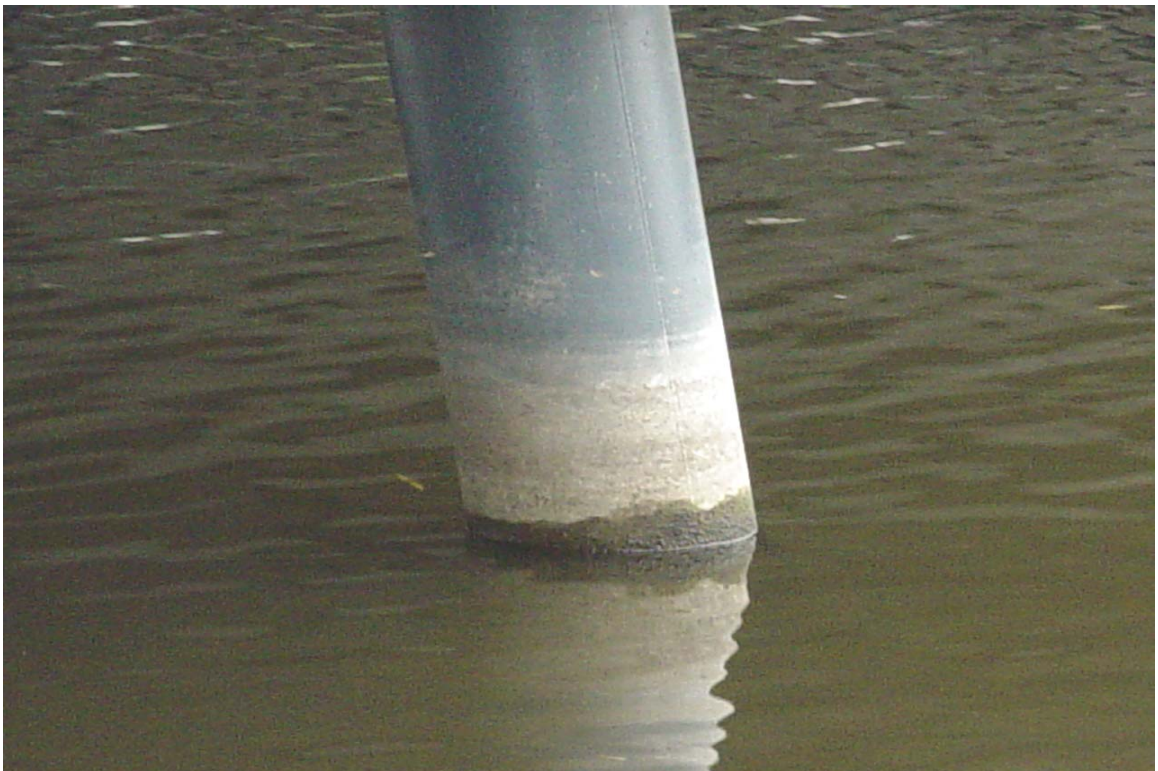
- (A) All of the piles for Piers 1 through 4 exhibited coating loss from 1 foot above the waterline to the mudline with light aquatic growth below the waterline. There was minimal deterioration present on the piles in the regions of the coating loss.

Photograph 6. Typical View of the Condition of the Piles at the Waterline.

- (A) Reinspect the submerged substructure units at the normal maximum recommended (NBIS) interval of five (5) years.
